DAM A-21

LAFAYETTE COUNTY, MISSOURI

MO 10144

# PHASE I INSPECTION REPORT NATIONAL DAM SAFETY PROGRAM

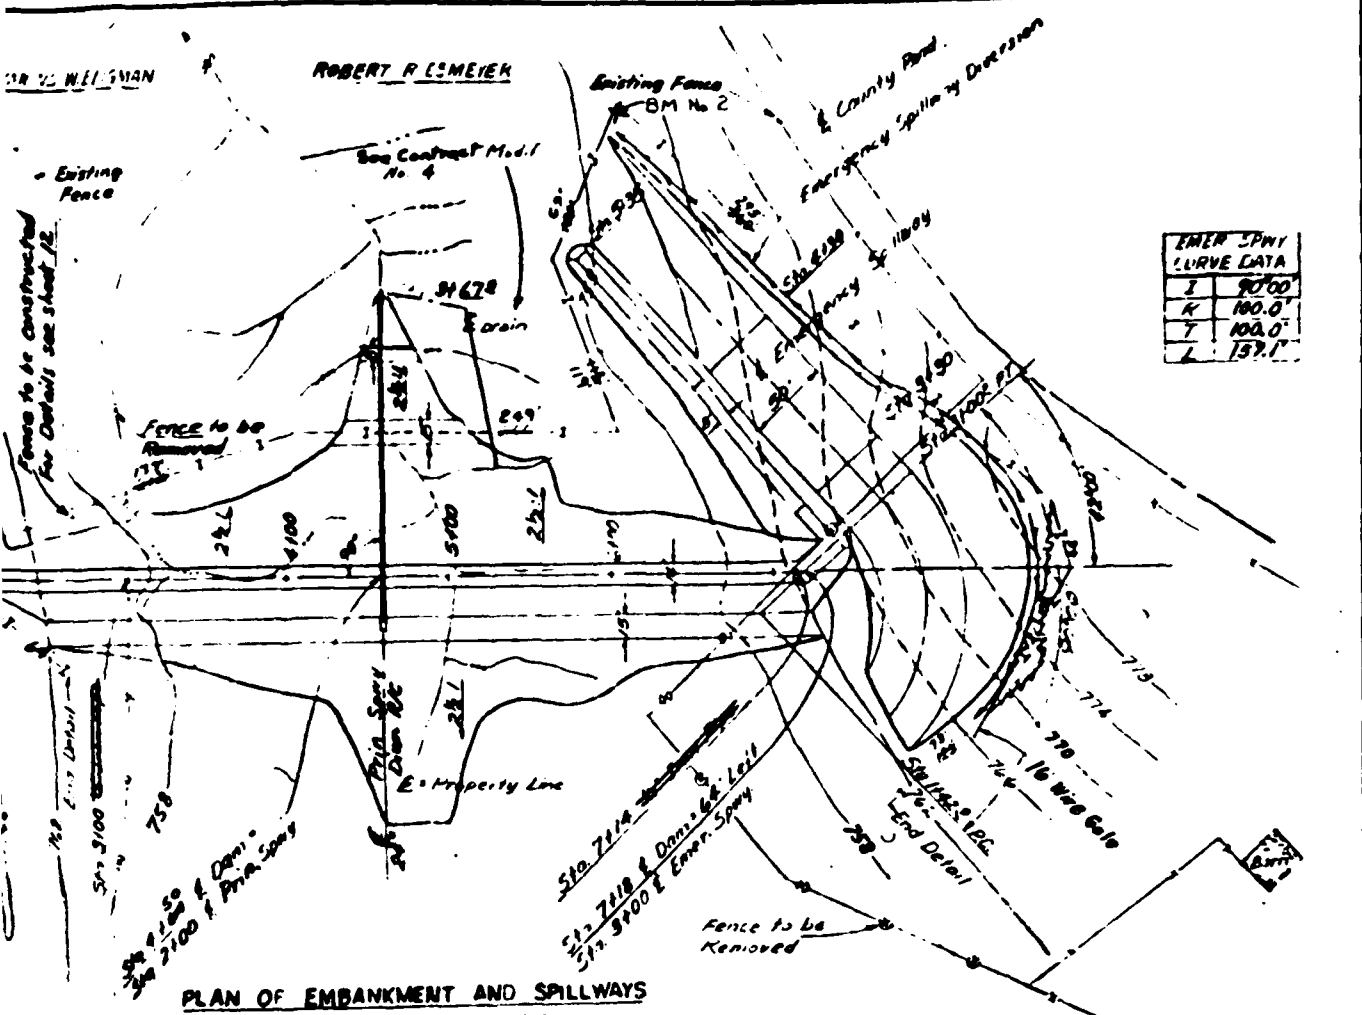
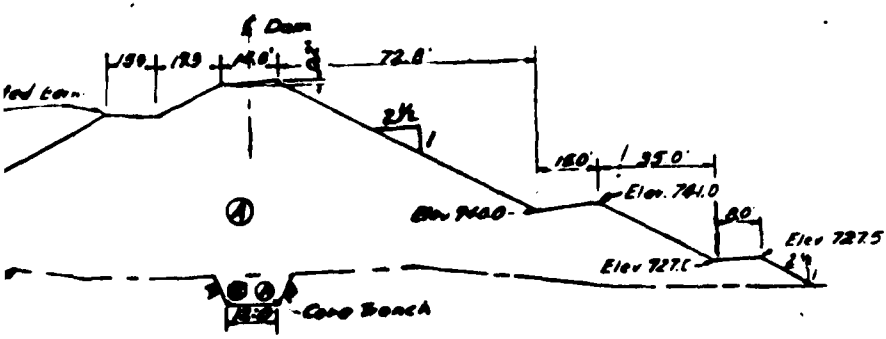
PLAN OF EMBANKMENT AND SPILLWAYS

Pertinent data about the dam, appurtenant works, and reservoir are presented in the following paragraphs. Sheet 4 of Appendix A is a plan of the embankment and spillways with a typical cross section of the dam. Sheet 5 presents a plan and profile of the primary spillway. Sheet 6 presents a profile and cross section of the foundation drainage system.

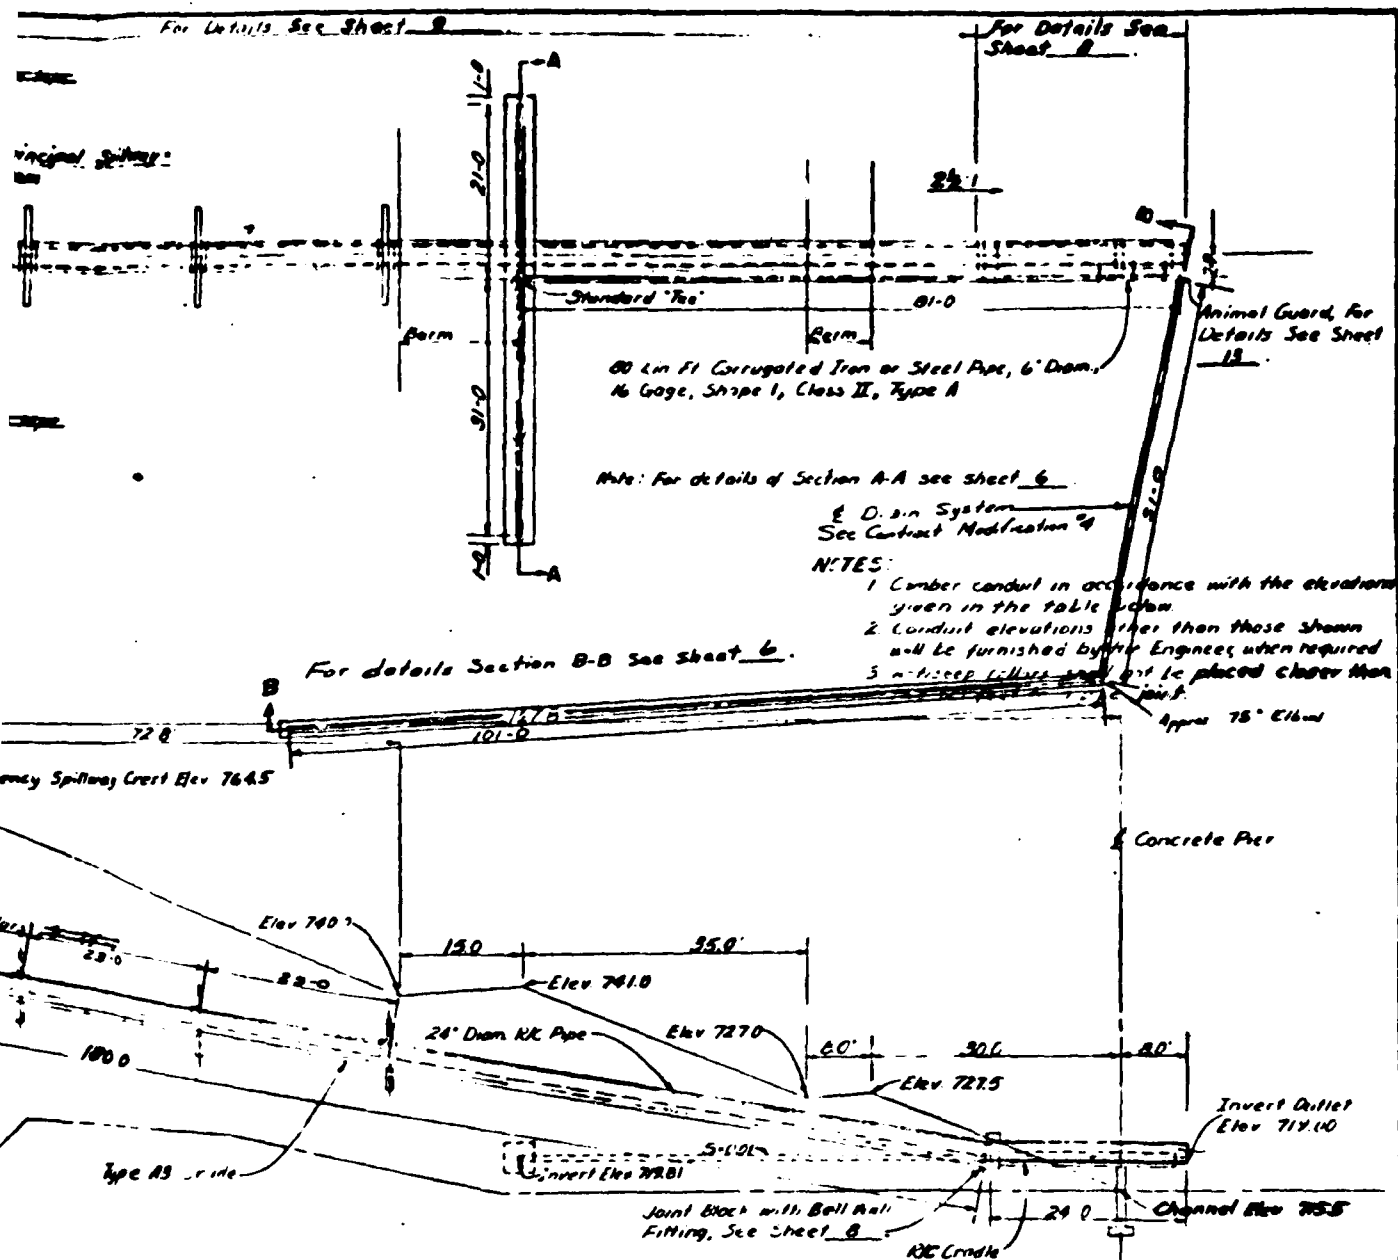
**SHEET 6 APPENDIX A**

Slope stability analyses were performed, but seepage analyses comparable to the Recommended Guidelines were not available. The foundation drainage system shown on Sheet 6 of Appendix A would indicate that a seepage analysis has been performed. The owner should either locate these analyses or have them performed by an engineer experienced in the design of dams.

Along the last portion of the primary spillway outlet pipe, there is a 6 in. diameter corrugated iron pipe (Class II, Type A), which is the outlet of the foundation drainage system for the embankment. The pipe has a length of 80 ft and a slope of 0.010. It is shown on Sheets 5 and 6 of Appendix A.
